Certificate of Approval Submittal

September 27, 2021

skB
ARCHITECTS

Overall Description (Existing building)

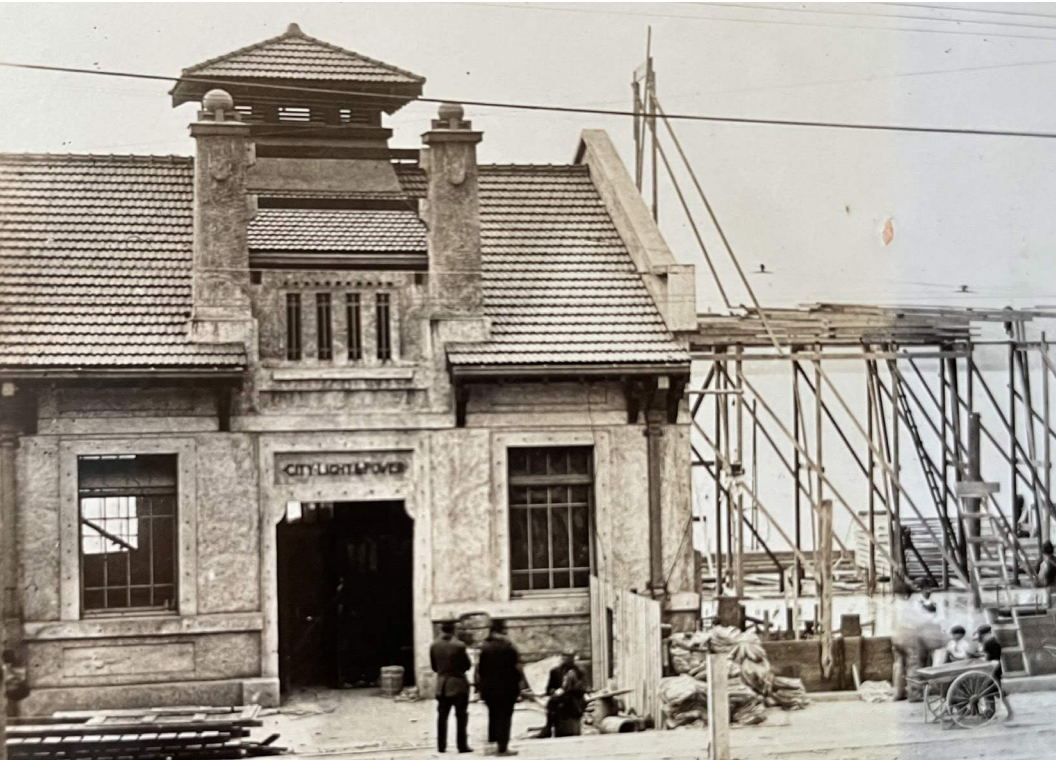
The Hydro House in 1914 showing the original recessed main entry

1. 1918 - moving the main entry (east) doors out to the plane of the exterior wall and eliminating the covered entry area.
2. 1991-1992 - All windows and doors were replaced as part of the rehabilitation for use as Zymogenetics offices and the associated cafe use. In addition, the back deck area was added. The small windows above the entry door and the penetrations for the electrical cabling were filled in. The windows above the main entry were replaced with new windows that do not reflect the historic configuration.

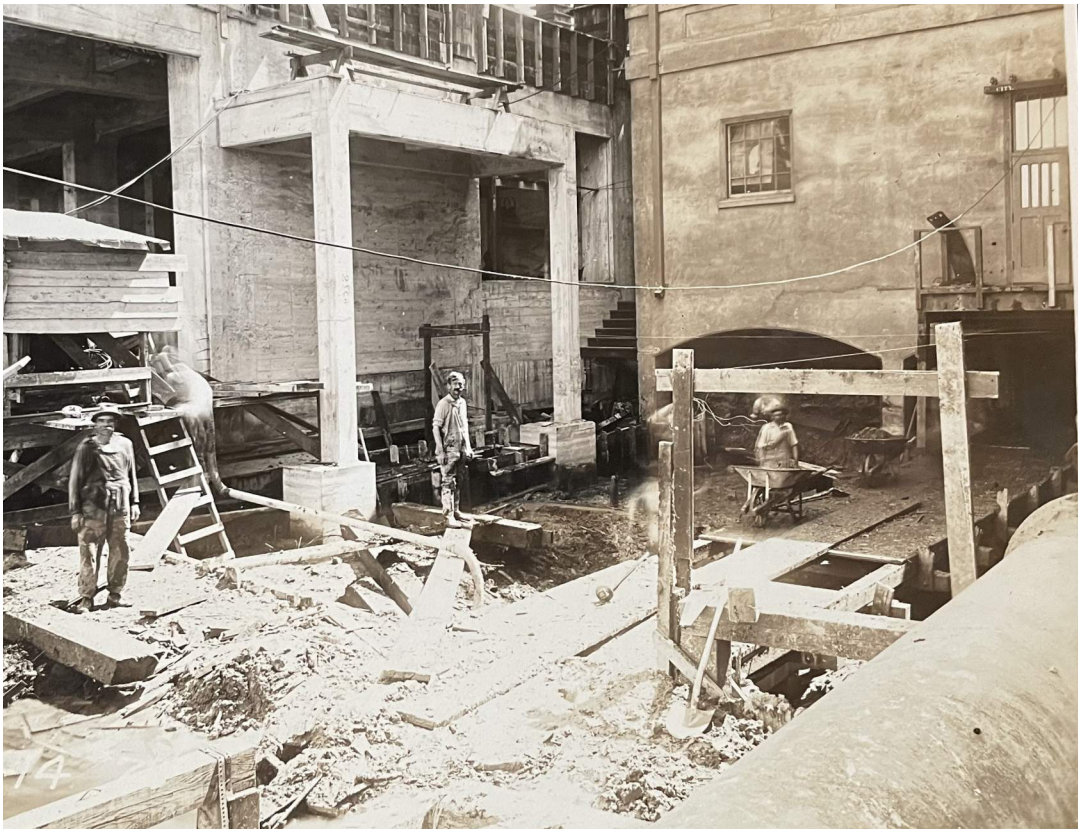
The west side of the 1912 Hydro House is shown in the upper right with the 1914 Lake Union Steam Plant addition on the left. The 36” diameter tail race pipe from the Hydro House is in the bottom left corner of the picture.

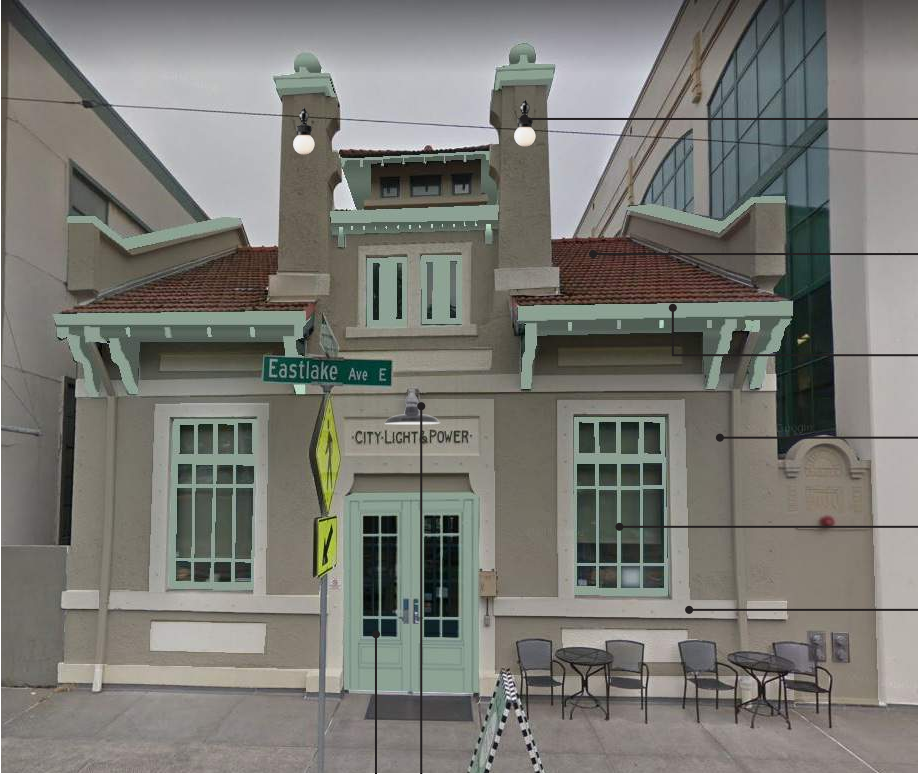
EAST ELEVATION (PROPOSED)

- New wall sconce mounted to each pillar (Fixture #3)
- Replace clay roof tiles with new "in-kind"
- Re-paint all roof eaves (Paint #3)
- Re-paint existing facade of building (Paint #2)
- Re-paint all window trims (Paint #3)
- Re-paint existing facade trims of building (Paint #1)

- New wall sconce above double doors (Fixture #1)
- New doors painted (Paint #3)

- Re-painting entire exterior building and accent trims. Building as it stands today shows only one paint throughout the whole exterior building, but in our historical analysis report, the original building actually had two different colours, which we propose to restore to its origin. (Sample analysis report conducted by Architectural Resources Group; additional information provided in Appendix.
- Adding exterior wall sconces to the entry doors and deck doors
- Re-painting existing window trims to match new doors. Color for trims and doors is selected to complement aesthetically to both the original paint colors on the exterior and the interior of the space.
- Proposing new front and deck doors

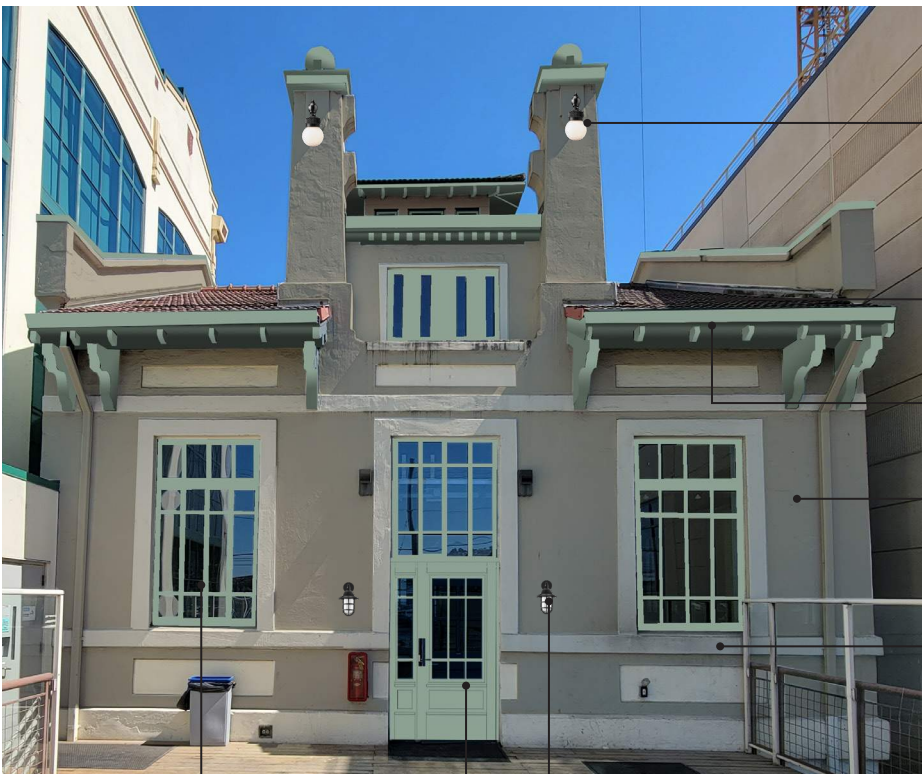
WEST ELEVATION (PROPOSED)

- New wall sconce mounted to each pillar (Fixture #3)
- Replace clay roof tiles with new "in-kind"
- Re-paint all roof eaves (Paint #3)
- Re-paint existing facade of building (Paint #2)
- Re-paint existing facade trims of building (Paint #1)

- New wall sconce adjacent door (Fixture #2)
- New doors painted and window trims (Paint #3)

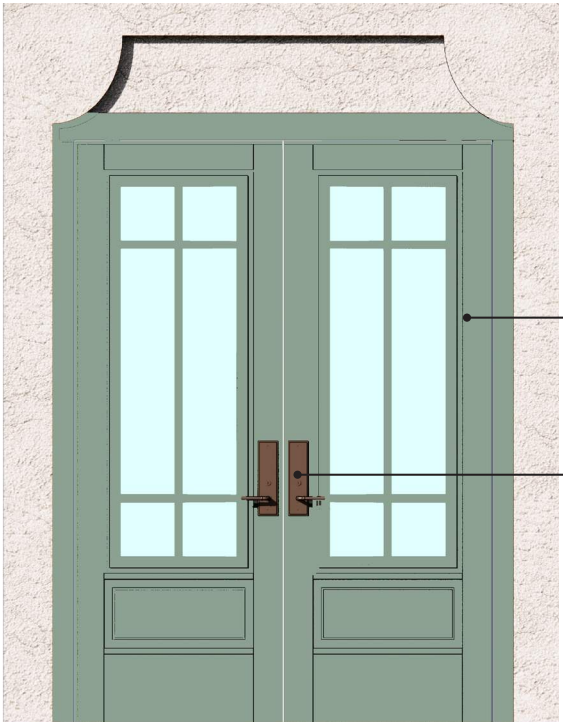
FRONT ENTRY DOOR (PROPOSED)

Paint #3 -
Sherwin Williams
SW6744 - Reclining Green

Rocky Mountain door
hardware - Corbel
Rectangular Collection:
Medium bronze finish

- Photos here show the evolution of doors over the years. We are proposing to replace existing front and deck doors with new, paint to match the “original” window trim and eave color.

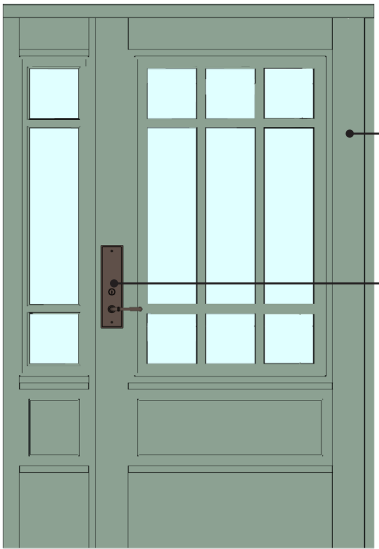
DECK DOOR (PROPOSED)

Paint #3 -
Sherwin Williams
SW6744 - Reclining Green

Rocky Mountain door
hardware - Corbel
Rectangular Collection:
Medium bronze finish

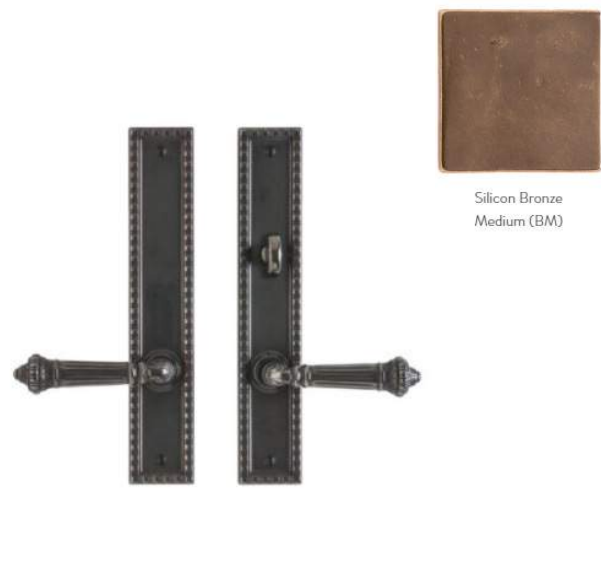
CORBEL RECTANGULAR
MULTI-POINT PATIO SET
2" X 11"

Exterior Escutcheon (E30761): 2" x 11"

Interior Escutcheon (E30762): 2" x 11"

Shown with [Capitol Lever \(L30161\)](#)

Shown in Patio Multi-Point for American Cylinder

Shown in Silicon Bronze Dark Lustre (BDL)

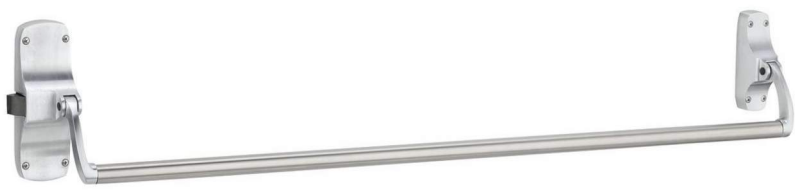
88 Rim exit device

88 rim devices for all types of single and double doors with mullion, UL listed for accident hazard installations. Covers stock hollow metal doors with 86 or 161* cutouts. This device is field reversible.

Device functions	Device ships EO, DT, NL, TP, L, K	
Handing	Field reversible	
Crossbar length	30" for 3' door, 42" for 4' door	
Device centerline	39 ³ / ₁₆ "	
Crossbar centerline to finished floor	36 ³ / ₁₆ " (935 mm) at center	
Lock stile case	8 ¹ / ₄ " X 2 ³ / ₄ " X ⁵ / ₁₆ " (210 mm x 70 mm x 24 mm)	
Hinge stile case	6" X 1 ³ / ₄ " X ⁵ / ₁₆ " (152 mm x 44 mm x 24 mm)	
Crossbar tubing	1" (25 mm) outside diameter	
Projection	Neutral – 4 ³ / ₄ " (121 mm) Depressed – 4" (102 mm)	
Latch bolt	³ / ₄ " (19 mm), throw	
Fasteners	All necessary mounting fasteners are included.	
Electrical options	RX	Crossbar monitor switch in end case
	E	Electric unlocking (BE trim only)
Mechanical options	RCB	Reinforced crossbar
	KN	Knurled crossbar
Strikes	299 - Dull black

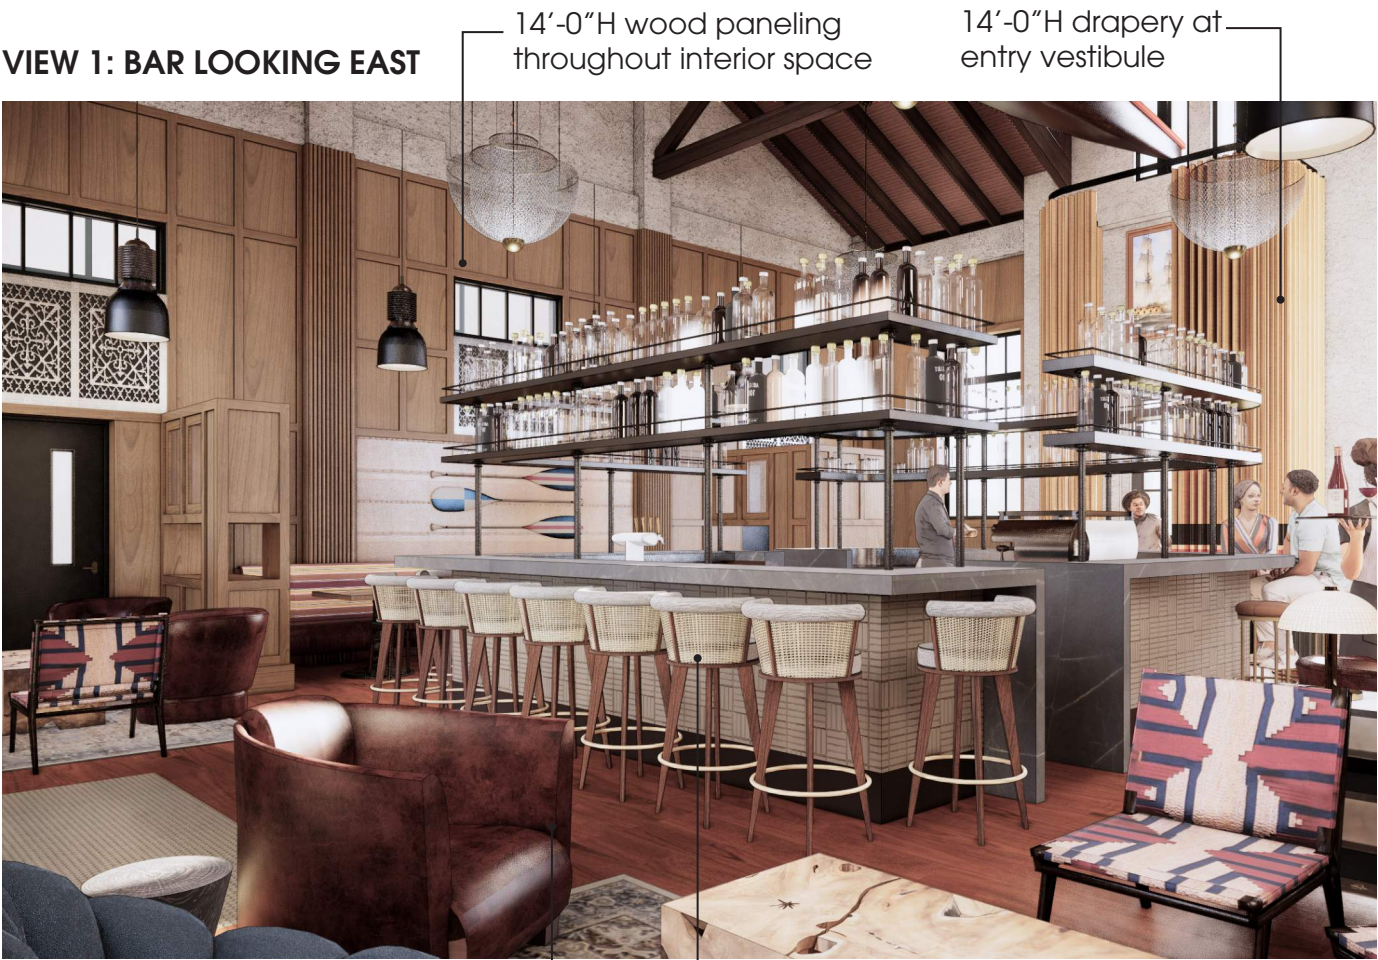
VIEW 1: BAR LOOKING EAST

Various types of furniture settings for customers to choose from

New coffee/wine bar at center of space with counter stools around

14'-0"H drapery at entry vestibule

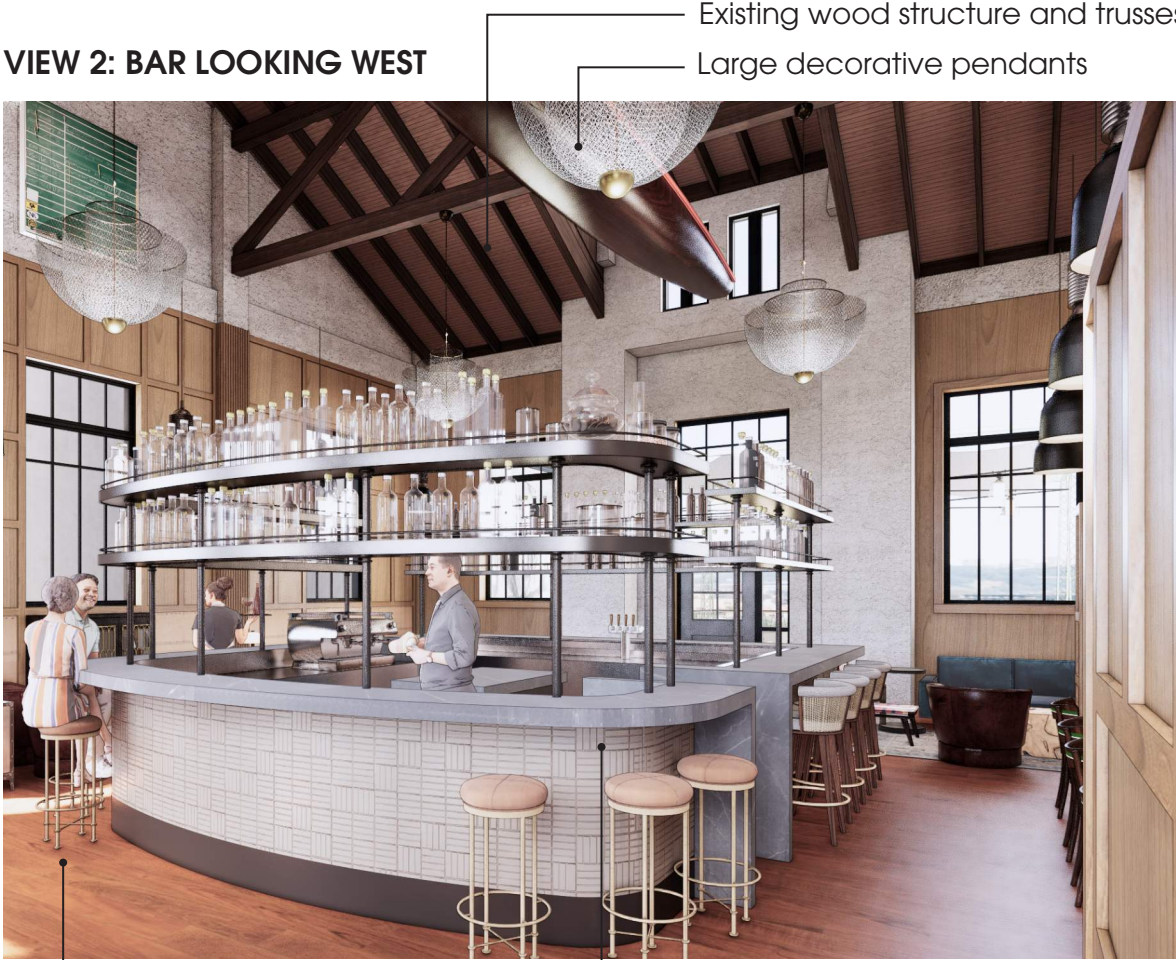
VIEW 2: BAR LOOKING WEST

New wood flooring throughout

New coffee/wine bar at center of space

Existing wood structure and trusses
Large decorative pendants

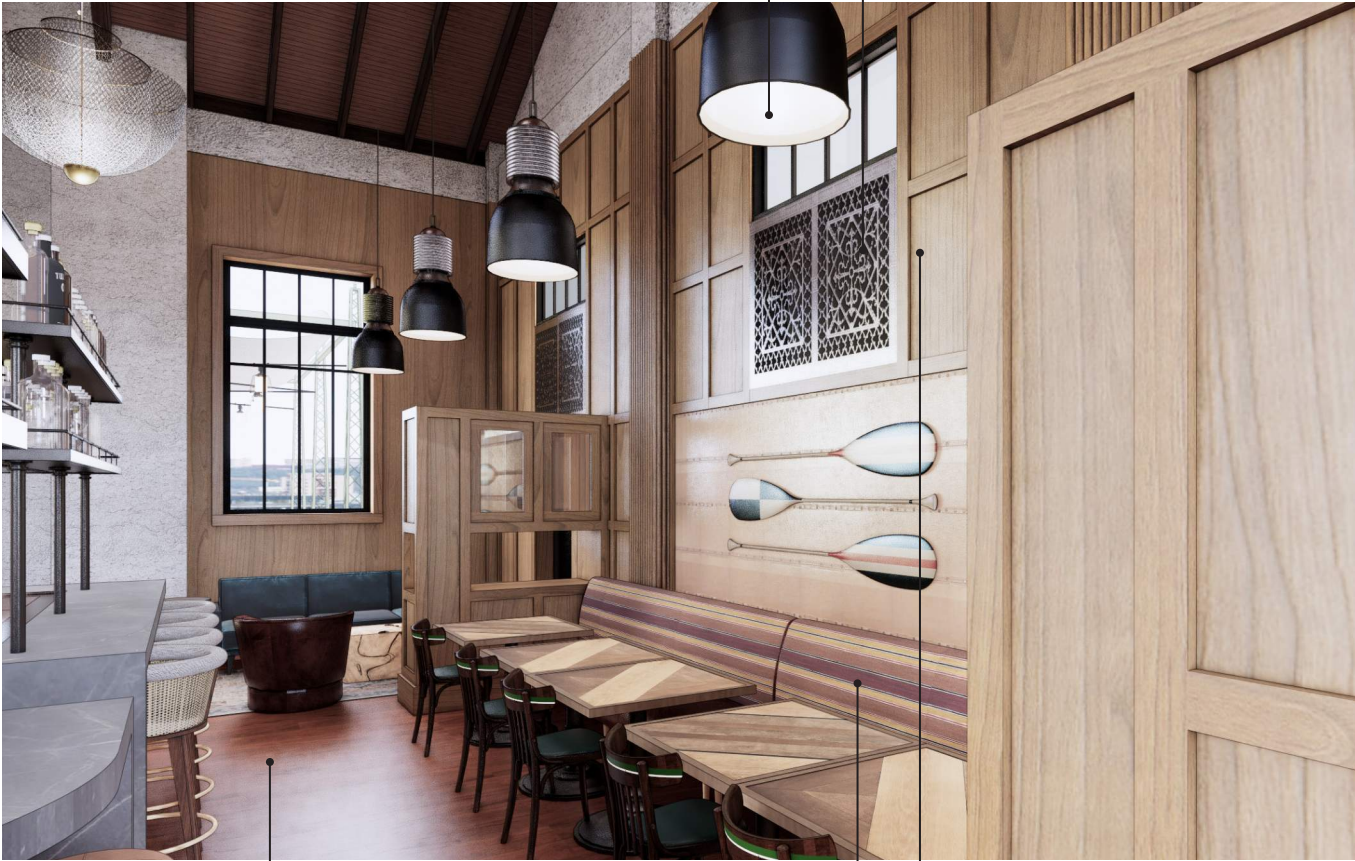
VIEW 1: BANQUETTE SEATING ALONG NORTH

New wood flooring throughout

Industrial pendant fixtures above seating area
Ornamental metal panel cover at existing HVAC grille

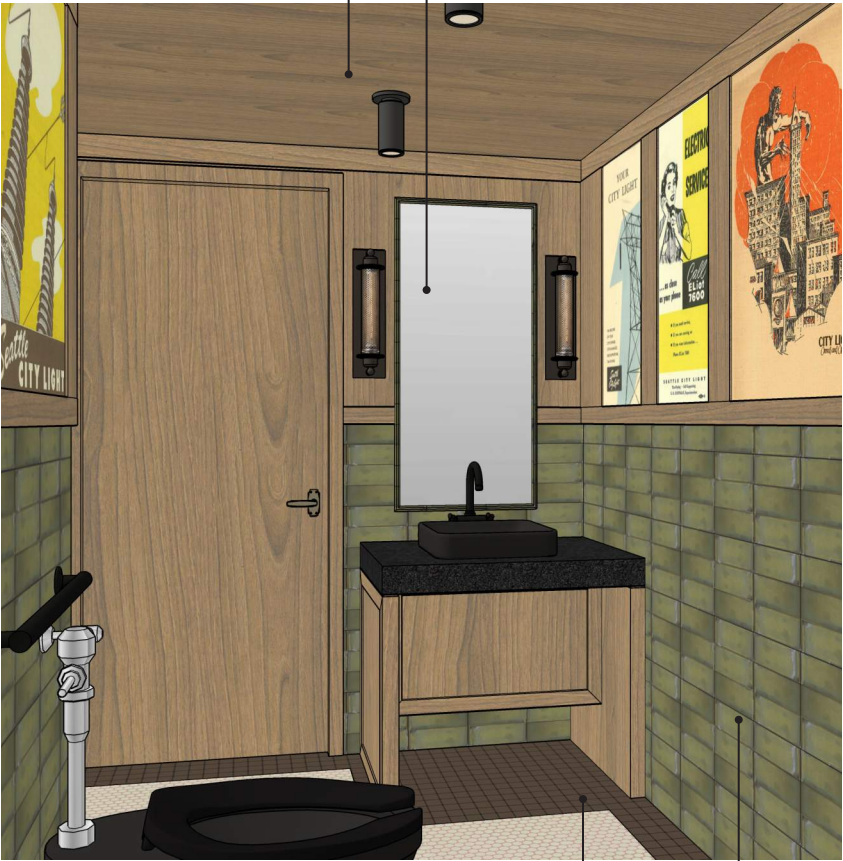
VIEW 2: RESTROOM

Wood wallcovering at
New toilet fixtures and vanity and accessories

Penny tile flooring
Wall porcelain tile wainscot with wood paneling above

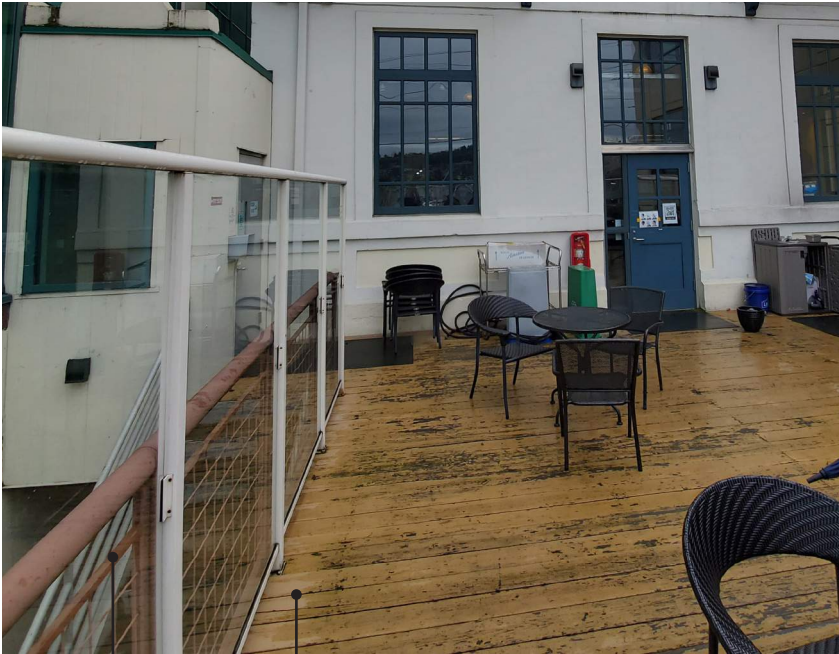
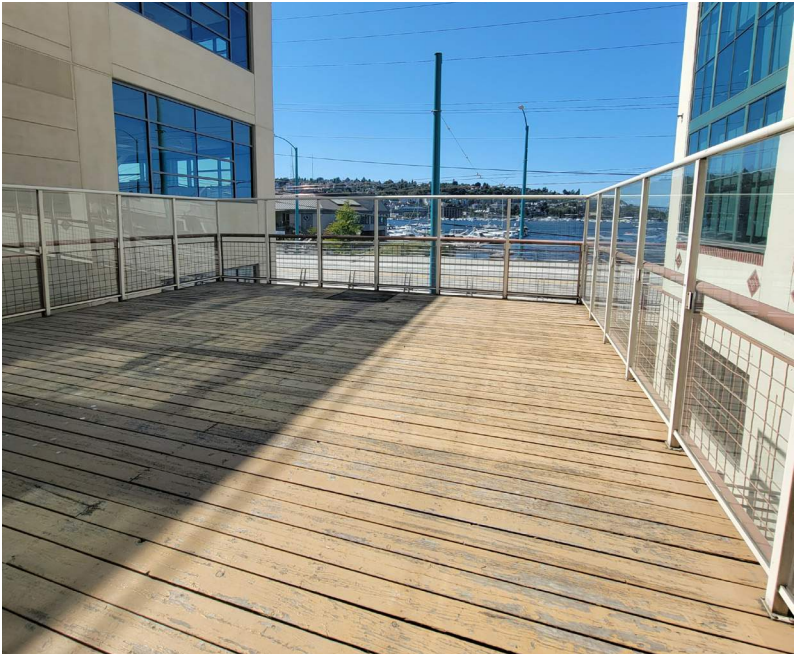
EXISTING EXTERIOR DECK

wood decking deteriorating

Double metal and glass guardrail system

- Replace decking and railing
- Adding new lighting and shading structure

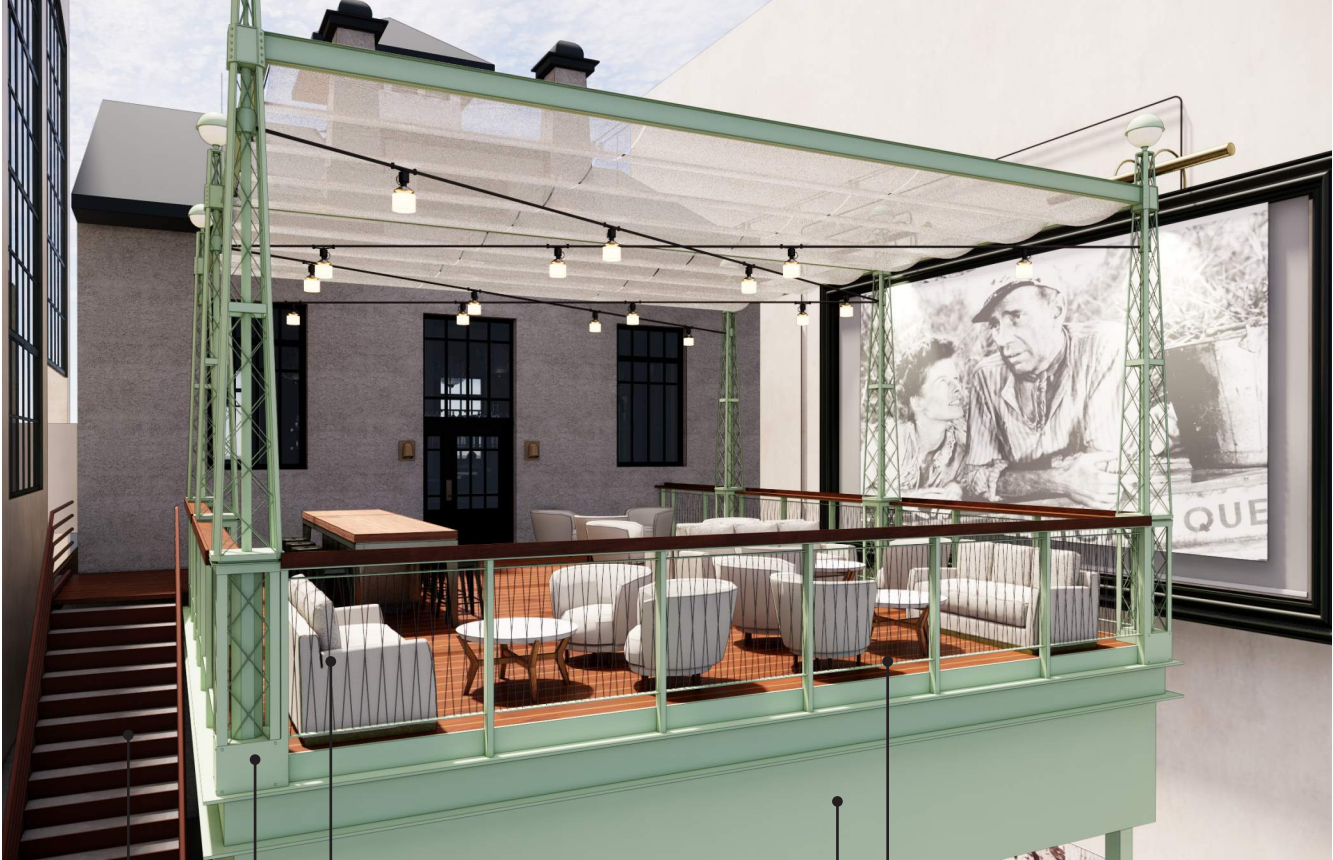
PROPOSED EXTERIOR DECK

Paint existing metal stair railing and risers

New cable rod guardrail system with wood top drink rail

Architectural columns supporting fabric shade structure and cantenary lights above

New wood decking throughout

New metal fascia around decking, painted to match exterior window trims

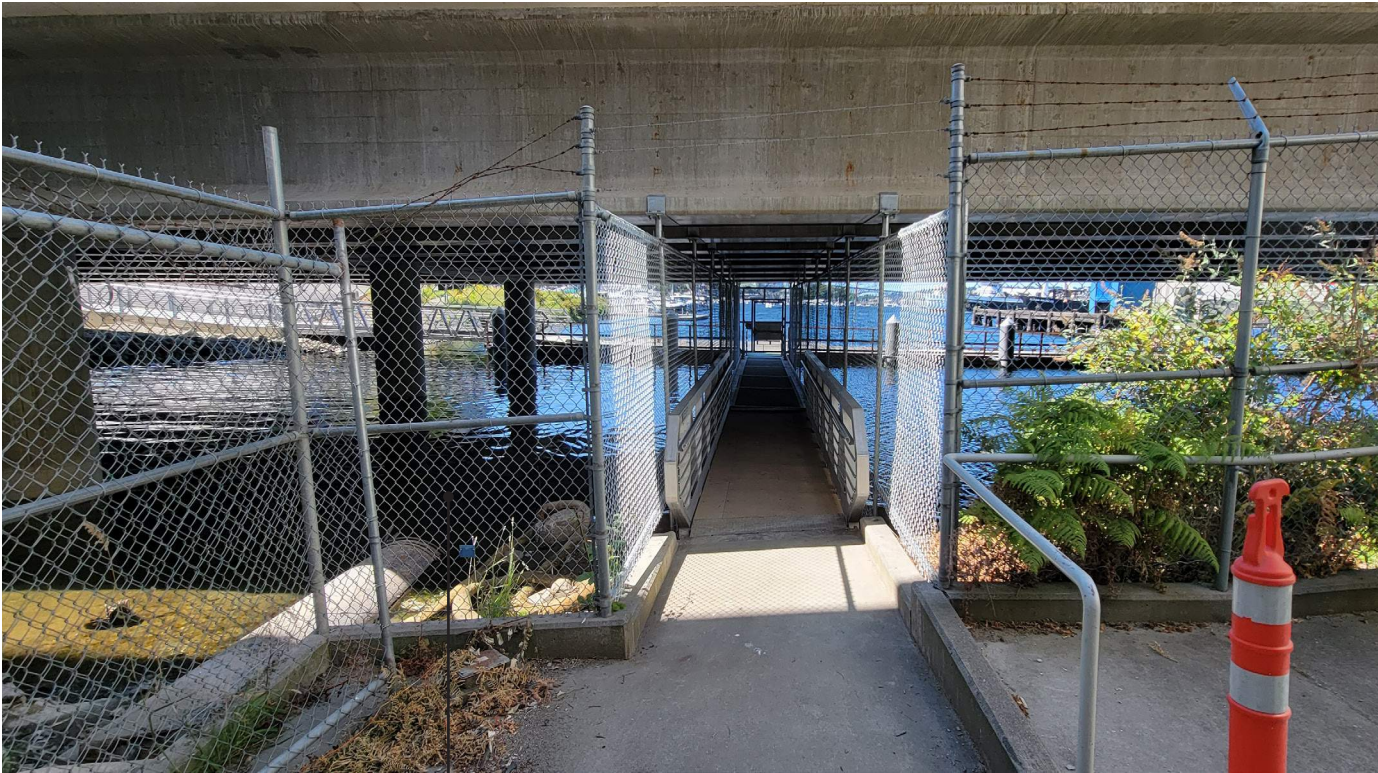
EXISTING LOWER LEVEL GATE

chainlink fence to dock

- Replace existing chainlink fence with new gate / fence at the property line
- New security gates at the storage area

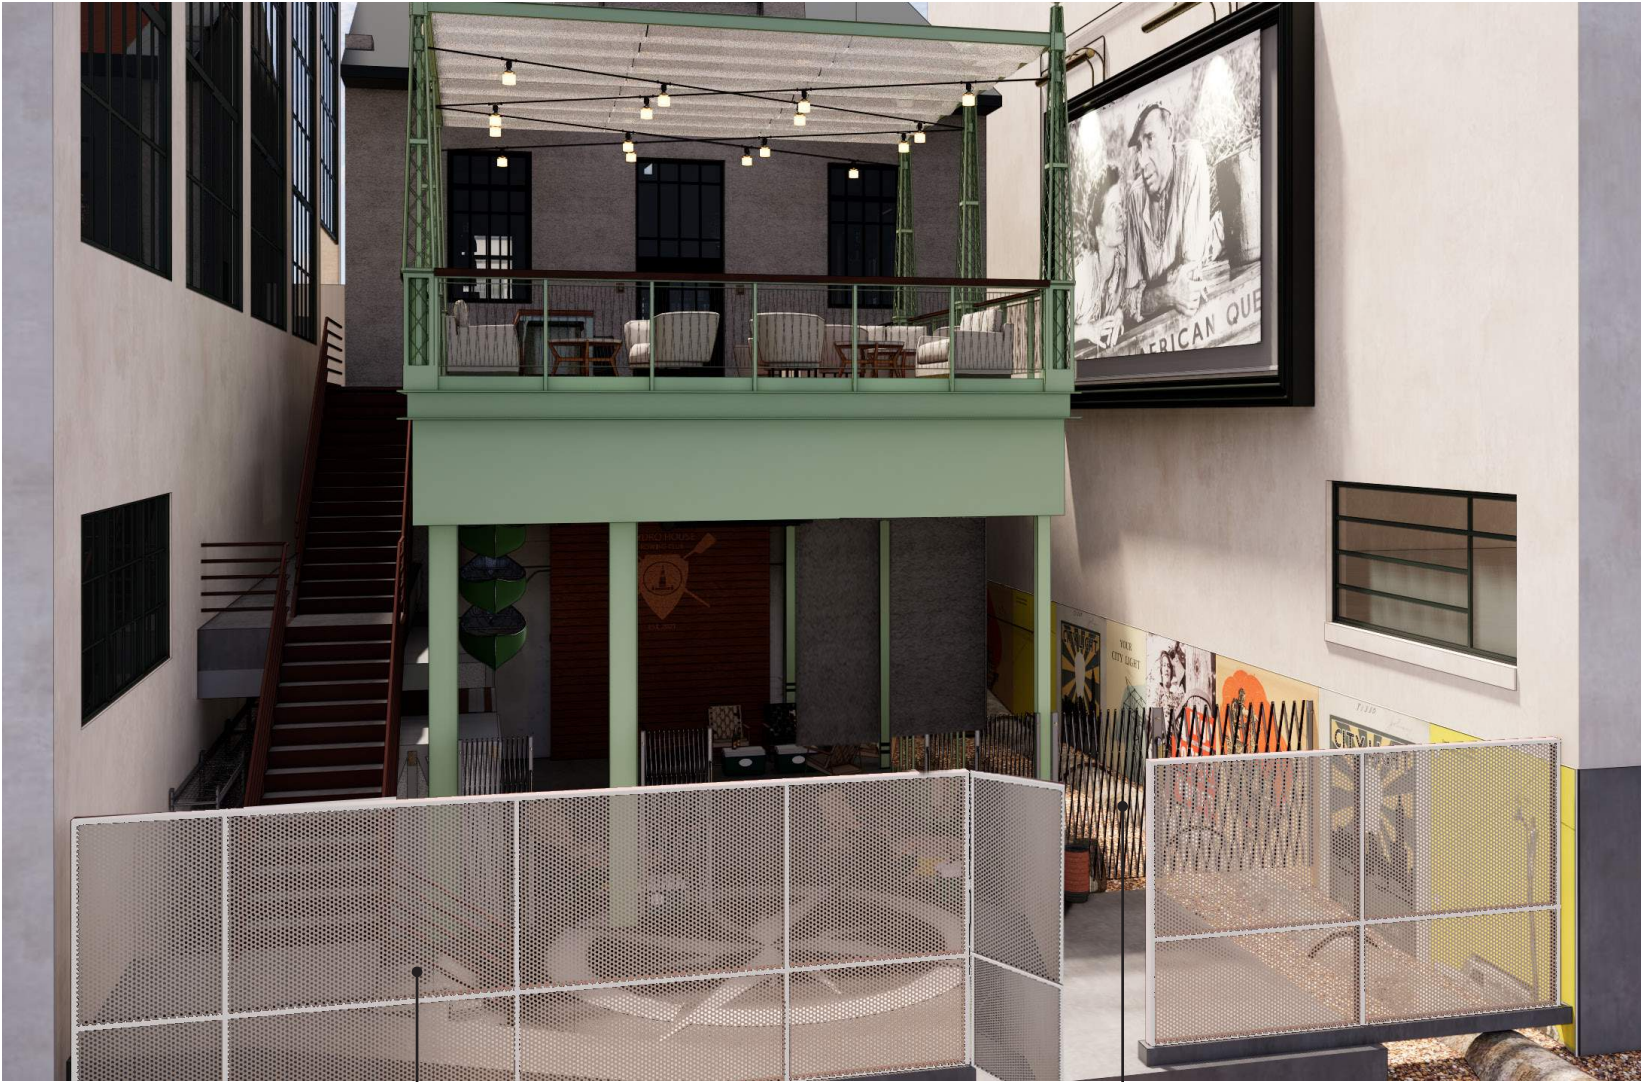
PROPOSED LOWER LEVEL GATE

8'-0"H mesh fence and gate

security gate behind at storage area

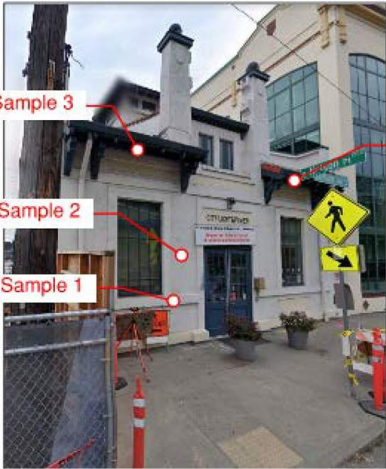
Façade of Hydro House with sample locations. Photo courtesy of Google Maps Street View.

Architectural Resources Group (ARG) was contracted to conduct a finishes analysis on select exterior elements at the Hydro House in Seattle, Washington. Samples were removed from four representative locations of Hydro House: the lower left rail (sample 1), the panel left of the door (sample 2), the east elevation north overhang (sample 3), and the east elevation south overhang (sample 4). Samples were collected by Richaven Architecture & Preservation Principal Brian Rich and by ARG Principal David Wessel. The samples consisted of stucco substrates taken from the walls with intact finishes and paint samples taken from the wooden eaves.

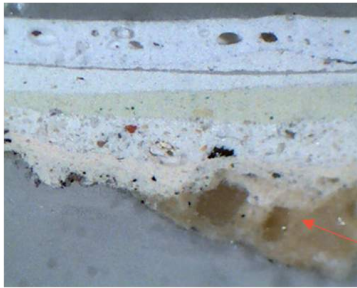
Sample 1, 50x magnification, halogen illuminator.

LAYER	COLOR	PRIMER/FINISH	MUNSELL MATCH	COMMERCIAL MATCH
1	Pale yellow green (stucco)	Finish	Munsell 2.5GY 8/2	Sherwin Williams #7050 Useful Grey
2	Pale yellow	Primer		
3	Pale yellow	Finish		
4	White	Primer		
5	Yellow white	Primer		
6	Yellow white	Finish		
7	White	Primer		
8	White	Finish

- Given the level of erosion of Layer 1, it seems that the stucco was left unpainted and was intended to be the finish layer.
- Layer 6 contains an unidentified line running through the layer. It does not appear to be a coating or a break in the sample and may be an artifact of sampling process. This layer is not found on the other stucco samples.

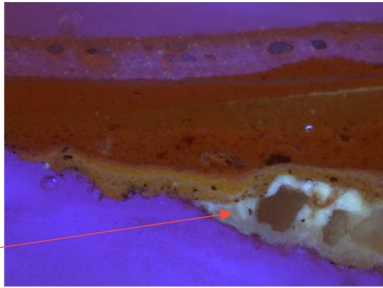
Sample 1, 50x magnification, UV illuminator

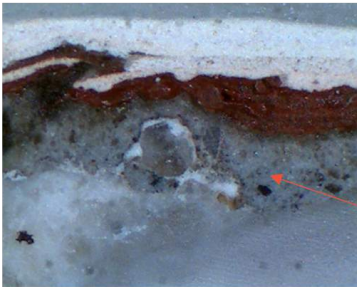
Sample 2, 50x magnification, halogen illuminator.

- Layer 1 is consistent with Sample 1, however given the level of erosion of Layer 2, it seems that the stucco was left unpainted and was intended to be the finish layer.

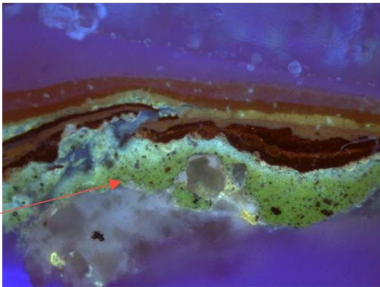
Sample 2, 50x magnification, UV illuminator
